### Aluminum Mounting Bracket for ATX-20 Explosion Proof HID Flashlights

CERTIFICATION TEST REPORT  
17961-1  
OF  
ATX20 Series (ATX-20-S, EPL-UV-20W, EPL-UV-20W-G2)  
and ATX25 Series (ATX-25-S)  
TO  
PERFORMANCE REQUIREMENTS OF UL-783  
ELECTRIC FLASHLIGHTS IN HAZARDOUS LOCATIONS

**REPORT NO.:** 17961-1  
**IMANNA JOB NO.:** 17961  
**CUSTOMER P.O. NO.:** VERBAL  
**CONTRACT:** N/A  
**PAGES IN REPORT:** 8

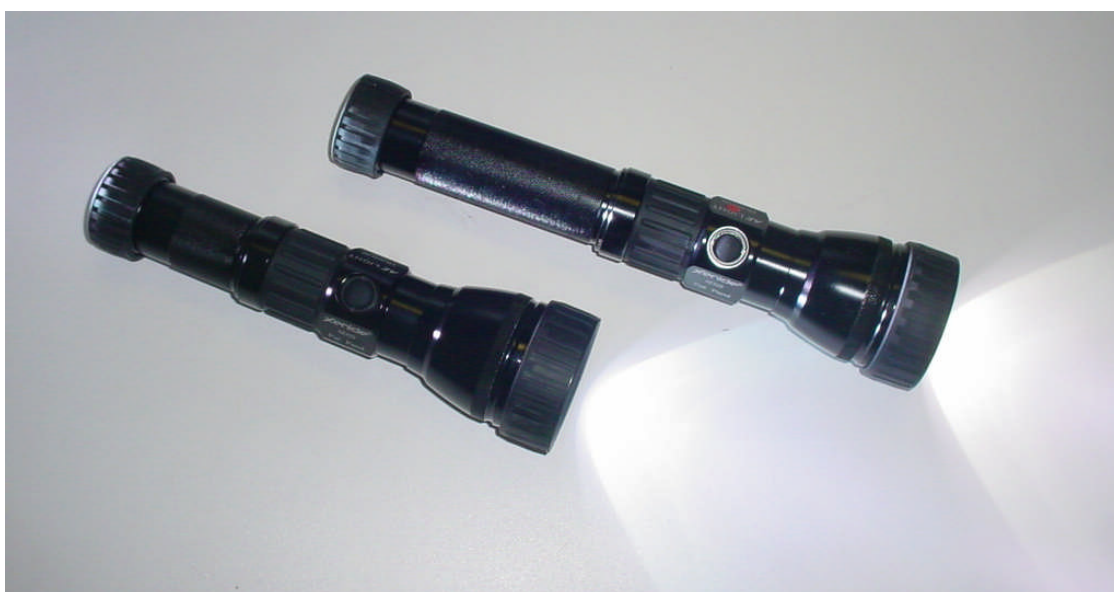
**Figure 1 View of the 20-watt and the 25-watt flashlights.**

Representative samples of two different size flashlight assemblies were received. One design operates with a 20 watt light source and the other with a 25 watt light source. The different lamp sizes require different size battery packs, making the 25 watt light a larger light in overall dimensions. The flashlights are designed with separate sections that thread together and are sealed at the threaded interface. One section is the battery section, another section is the electronics section, and the third section is the lamp source section.

The lights are activated by a switch placed under a flexible rubber pad that is sealed to the housing body of the flashlight. The switch is a “push-to-ON” and “push-to-OFF” switch that is not exposed to the outside atmosphere due to the seal of the rubber pad over it.

The lamp lens is covered with a slip-over rubber ring that forms a cushion around the edge of the lamp lens assembly and protects the lens from high force impacts at the edge of the lens plate.

The opposite end of the flashlight is covered with a rubber boot that forms a bridge for the light is dropped on its side. The force would be absorbed by the front lens cover and the rear end cover instead of the metal body.
